**Linaschke & Co., LLC**  
**NATIONAL AIRCRAFT APPRAISERS ASSOCIATION**  
**Aircraft Appraisal Report**

**Aircraft Identification**

**Make:** CESSNA AIRCRAFT COMPANY      **Model:** 550 - Citation II

**Serial No.** 550-SER#      **Reg. No.** NREG#      **Yr. Mfg.** 1981

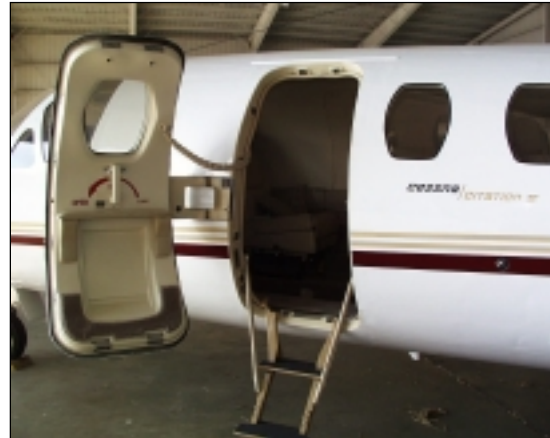
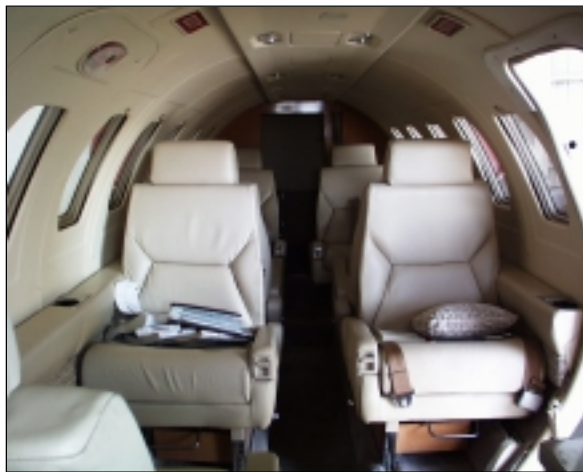
**Comments:** Although newly painted, there is evidence of cracking and peeling at the co-pilots window attachments, and at the passenger entrance door. There appears to be some corrosion on fasteners under the paint, and poor adhesion at a few locations. For example, the paint is lifting from screw heads under the co-pilots window.

There is some evidence of corrosion remaining under the new paint, especially in the vicinity of the co-pilots windshield. The aircraft has a new Certificate of Airworthiness, however the extended period of time during which the records indicate the aircraft was neither flown nor maintained warrants further investigation.

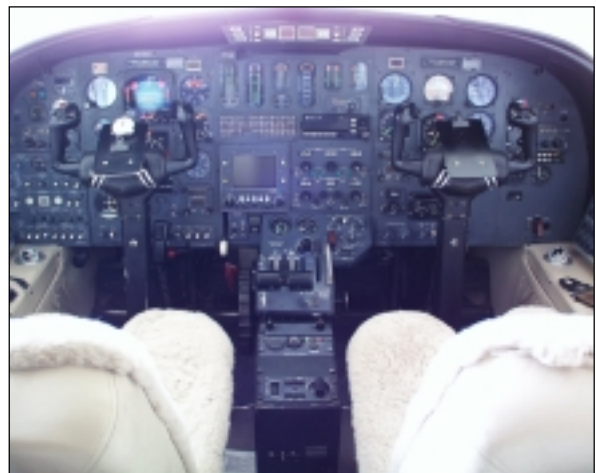
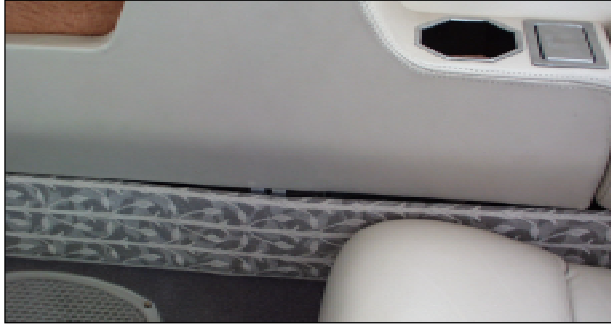
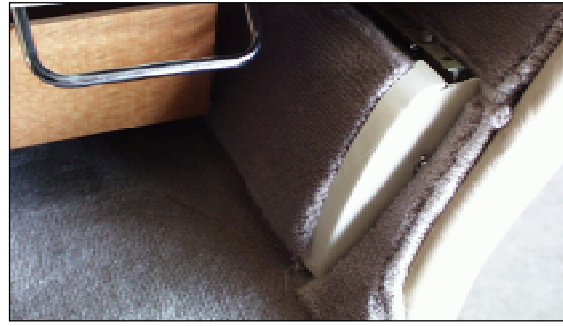
**Comments:** Although the interior is new, there are some areas where the carpet and side panels are not adhered to the structure. The carpet serging is loose in many places, and some areas have cut carpet edges without serging.

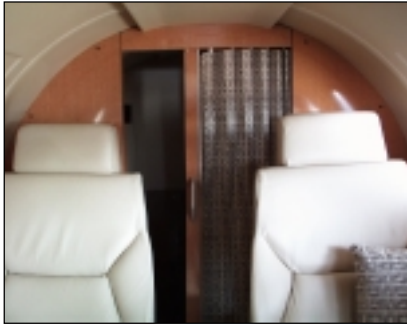
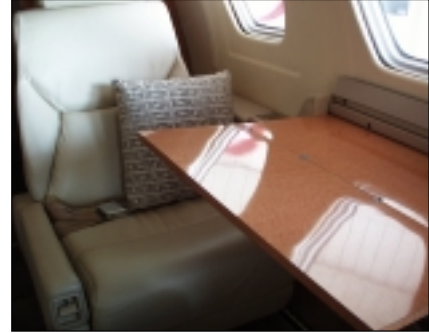
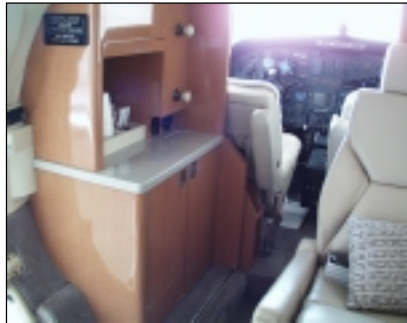
The airplane shows well with all new glass, and its' new white, beige and maroon paint, and beige leather interior with complementary carpets and paneling. The aircraft looks to be in good condition, however there are some cosmetic defects in the paint and interior that detract from the overall appearance

quality. For example, the interior side panels are pulling away from the structure in several places; the lavatory screen binds, and the club tables are not rigid when extended. The stitching in the seats is not beaded, and the serging on the carpet is loose in some areas.
